# Bunker silo wall loads

J. C. JOFRIET<sup>1</sup>, Q. ZHAO<sup>1</sup>, D. E. DARBY<sup>2</sup>, and H. BELLMAN<sup>3</sup>

Jofriet, J. C., Zhao, Q., Darby, D. E. and Bellman, H. 1989. **Bunker silo wall loads.** *Can. Agric. Eng.* **31**: 187-193. Structural problems in the precast concrete walls of some large bunker silos in Alberta have raised questions about the adequacy of the 1983 CFBC design loads for high (over 3 m) bunker silo walls. This paper examines these design loads in light of design procedures used for earth retaining walls. One of the A-frames with structural problems is analyzed to try to explain the observed cracking. Also, the preliminary results of a full-scale experiment on a bunker silo with a 4.9-m-high wall are provided. Only static wall loads have been considered thus far. The stored material was corn silage with an average moisture content of about 71% at the time of loading. The average bulk density was approximately 870 kg/m<sup>3</sup>. Analysis of the silo frame using equivalent fluid pressures indicated the highly stressed areas. Bending moments and shear forces exceeded the strength at several points. The experiments showed that pressure increas

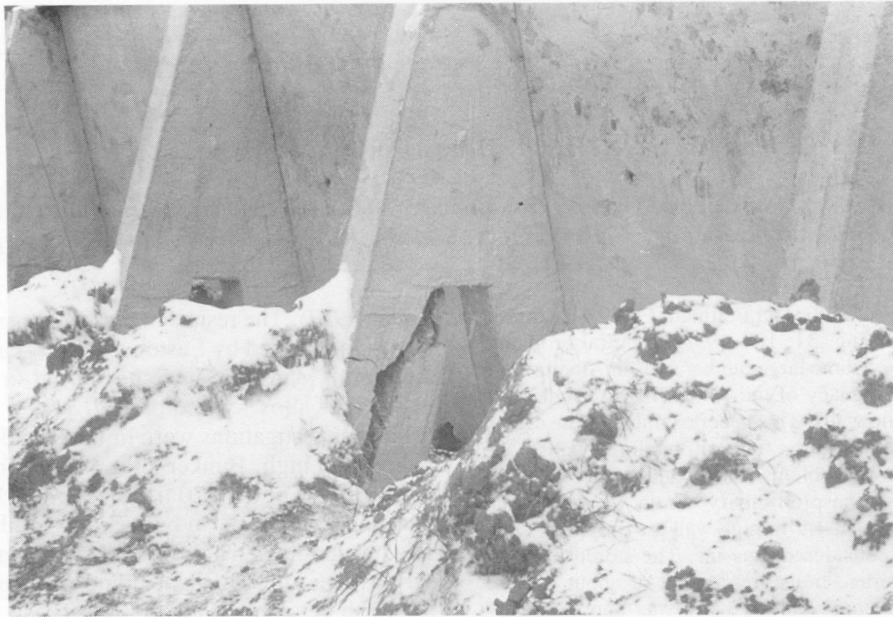
Figure 1. Break in the top of the rear leg of a bunker silo support frame; crack initiated by a combination of high negative moment and shear.

The principles of retaining wall design (Craig 1978) were applied to the analysis of a 6.1-m-high bunker silo built in Alberta from Canada Plan Service (CPS) (1982) plan no. 7435. The wall slopes 14° with the vertical. At least one of the A-shaped support frames of this silo is very severely cracked at the top of the rear leg (Darby 1986, personal communication) (Figs. 1 and 2). The analysis was carried out to find the cause of the failure (Jofriet 1987, personal communication).

The actual behavior of the frame probably lies somewhere between the internal forces presented in Figs. 7a and 8a, and those in Figs. 7b and 8b. However, the results of the two analyses clearly indicate where severe cracking is likely to occur. The most highly stressed areas are (1) the bottom of the front leg with tension on the outside face of the frame, and high shear forces (Fig. 4), (2) the center of the front leg with tension on the inside face (Fig. 3), and (3) the top of the rear leg with tension on the outside and again a moderately high shear force (Fig. 1).

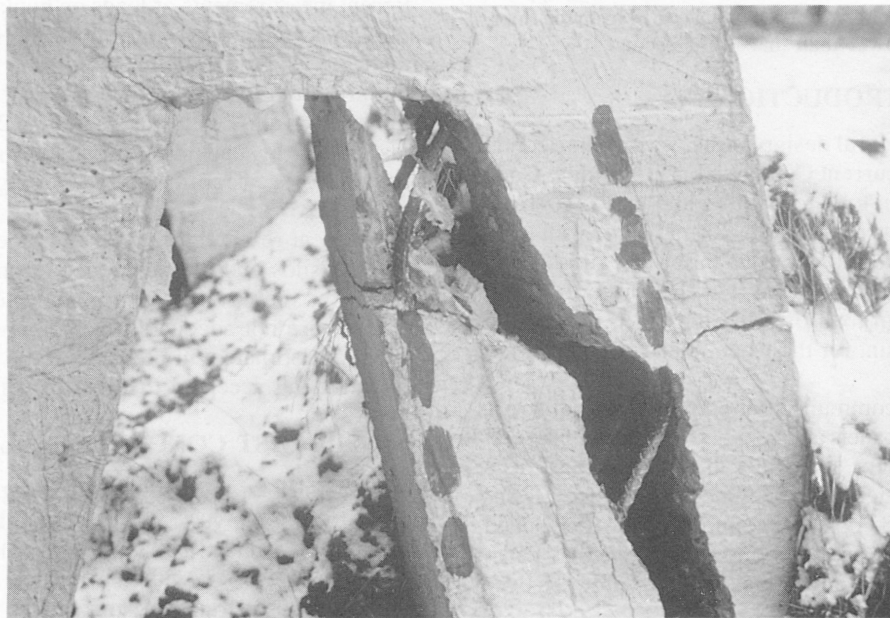
Figure 2. Close-up of the break illustrated in Figure 1.

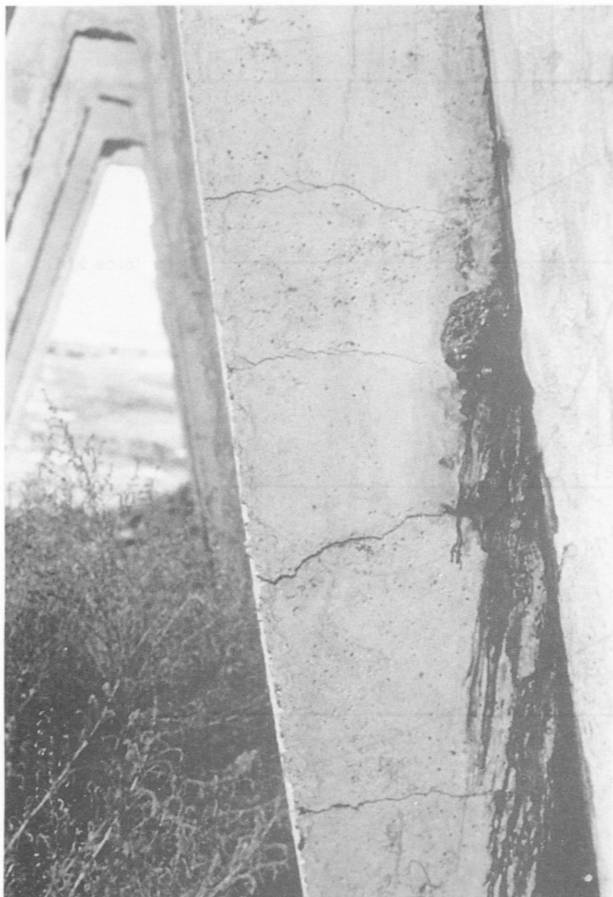
Figure 3. Positive moment cracks in the front leg of a bunker silo support frame.

Darby (1986, personal communication) reported serious structural cracking in the wall panels and support buttresses of several concrete 6.1-m-high bunker silo walls in Alberta (Figs. 1, 2 3 and 4). Two of three independent engineering reports (Turnbull et al. 1987; Jofriet 1987 personal communication) concluded that the design loads specified in the present Canadian Farm Building Code are not sufficient for bunker silos with walls over 2.5 m high.

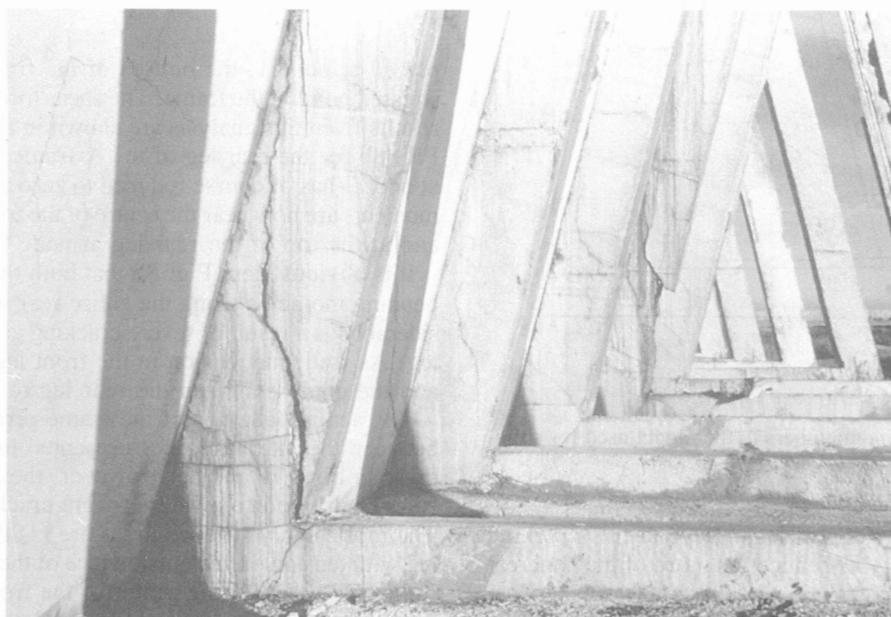
Figure 4. Cracks in the bottom of the front leg of a bunker silo support frame; cracks initiated by a combination of high negative moment and shear.

It is clear that, since no stirrups were used, the legs are susceptible to failures where high bending moments and high shear forces act at the same location such as at the bottom of the front leg and at the top of the rear leg. This mode of failure, shown clearly in Fig. 4, occurred in several silo frames (Darby 1986, personal communication).

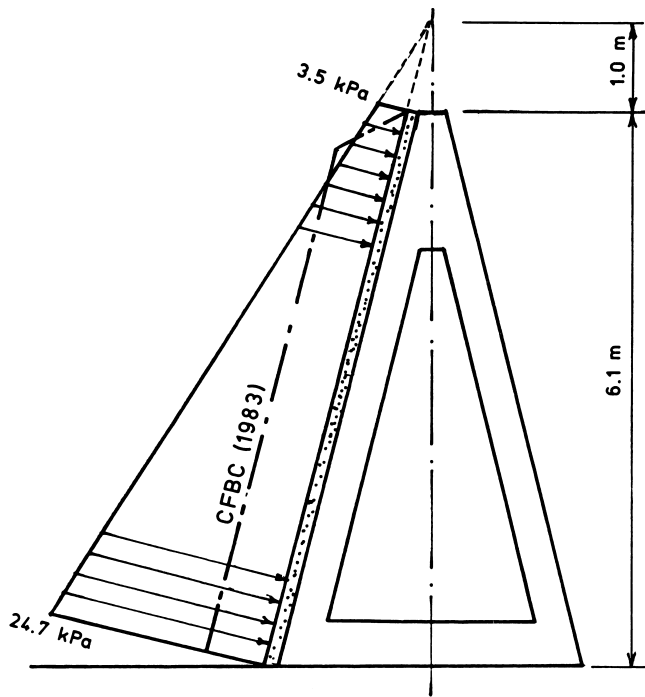
Figure 5. A-frame supported bunker silo wall subjected to a linearly increasing pressure; CFBC (1983) pressure shown for comparison.

Assuming  $k = 0.5$  and given the wall slope of  $14^\circ$ ,  $k'$  is 0.53 and the maximum pressure normal to the wall then is  $0.53 \times 46.7 = 24.7 \text{ kPa}$ . The resulting wall pressure diagram is shown in Fig. 5. The CFBC (1983) pressure diagram has been included for comparison.

The A-shaped support frame was analyzed for the pressure diagram in fig. 5 using a linear elastic frame analysis program. The frame model is shown in Fig. 6. Both legs were assumed fixed at the bottom. The shear forces and bending moments along the front leg are plotted versus position in Fig. 7a. Similarly, the shear force and bending moment diagrams for the rear leg are shown in Fig. 8a. The front leg has a tensile force of 96 kN, the rear leg a compressive force of 119 kN. The shear and bending resistances of the legs of the A-frames were analyzed (CSA A23.3 1984) for a silo frame built from CPS plan no. 7435. The factored bending strength of the A-frame legs was calculated to be 65.3 kN.m, the factored shear resistance was 54.3 kN.

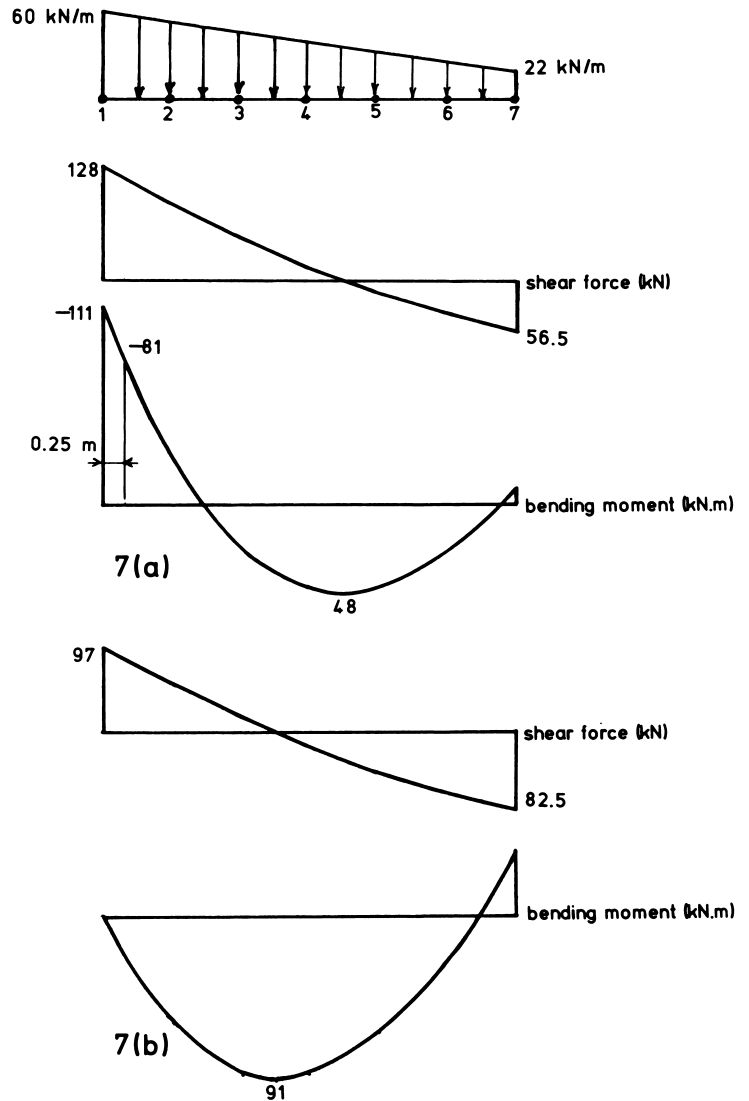
Figure 7. Shear forces and bending moments in the front leg.

The largest bending moment is at node 1 at the bottom of the front leg of the A-frame. At the top of the horizontal cross member,  $M = 81 \text{ kN.m}$ , 24% greater than the calculated factored bending strength. There is also a high shear force at that location. The linear elastic assumption is a gross oversimplification of the actual behavior in the case of reinforced concrete structures. The moment-curvature relationship of reinforced concrete sections is non linear after the concrete in the tension zone cracks. This is estimated to occur at a moment of about

placed at node 1, the bottom of the front leg and the highest stressed point of the frame. The shear force and bending moment results from this analysis are shown in Fig. 7b for the front and Fig. 8b for the rear leg of the A-frame. The bending moment at node 1 has of course reduced to zero and the largest bending moments are now near the centre of the front leg ( $M = 91$  kN.m) and at the top of the rear leg at node 8 ( $M = 96$  kN.m).

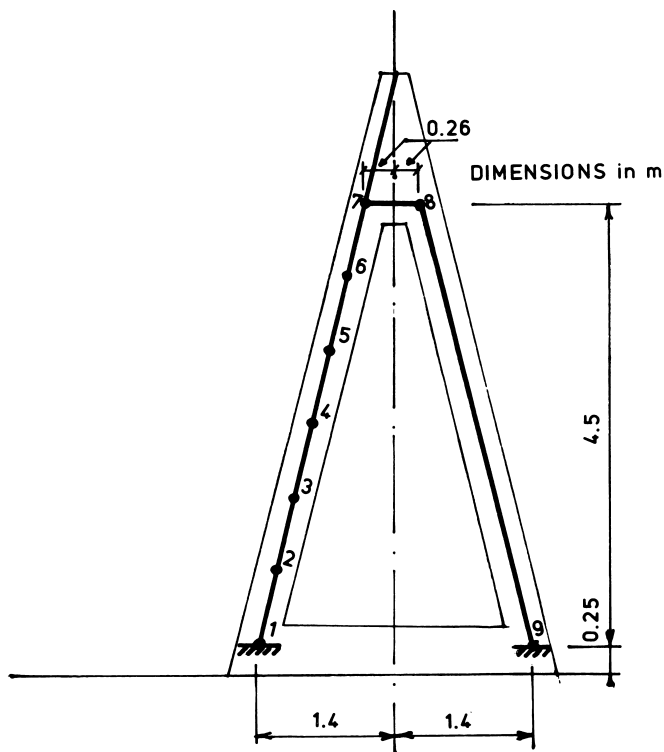
Figure 6. Layout of nodes and members in the model used for structural analysis of A-frame.

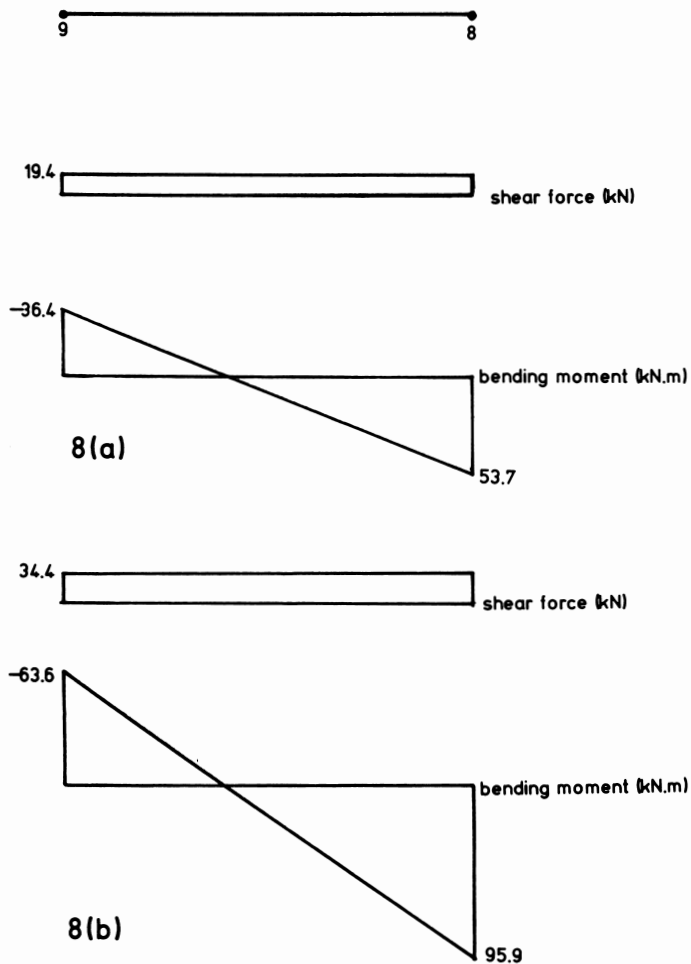
Figure 8. Shear forces and bending moments in the rear leg.

It is obvious from Fig. 8b that both the shear forces and the bending moments along the entire rear legs are increased considerably as a result of severe cracking at the bottom of the front leg. As well, the tension in the front leg increased to 119 kN and the compression in the rear leg to 153 kN.

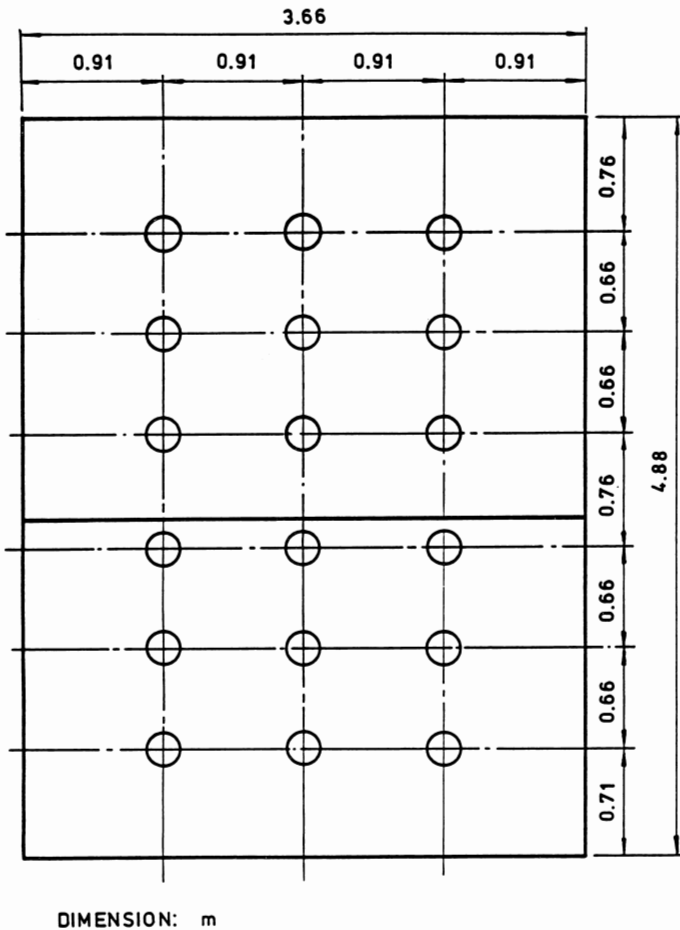
Figure 9. View of the test panel with layout of circular hole for force transducers.

Wall pressure measurements are made by means of strain gauge based force transducers. One of the precast wall panels is equipped with three vertical rows of six transducers providing force measurements over an area of about 0.03 m<sup>2</sup> at spacings of approximately 0.66 m vertically and 0.92 m horizontally. A layout of the force transducers is shown in Fig. 9.

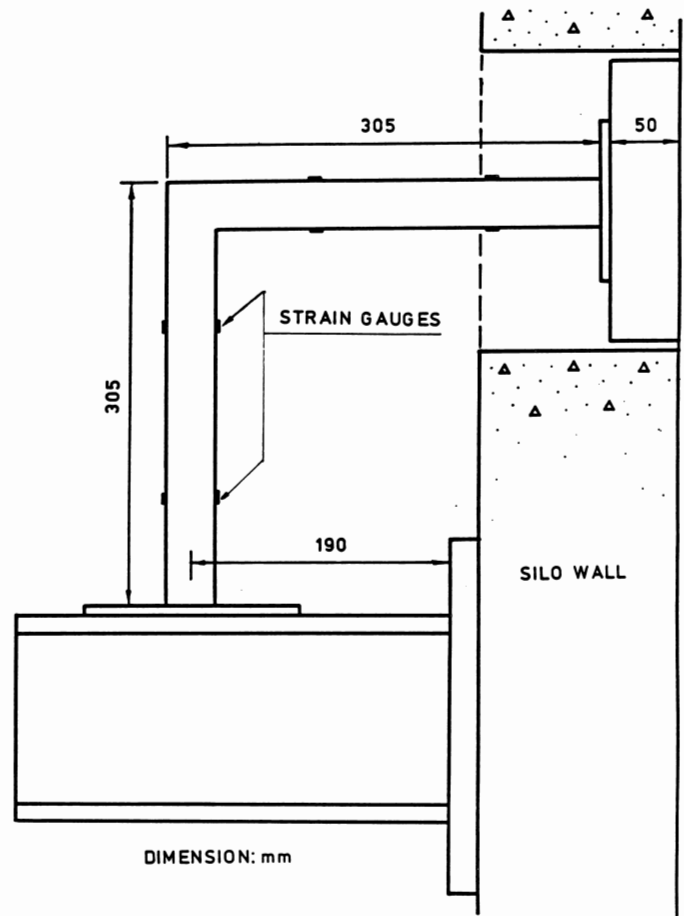
Figure 10. Side view of a force transducer supported on a WF beam bracker.

The design of the wall transducers is such as to provide a contact surface with the stored material flush with the face of the silo wall. The contact surface is also designed to have a texture that is similar to that of the silo wall so that meaningful friction force measurements can be made. A 200-mm-diameter concrete filled disk supported firmly by an L-shaped stainless steel tubular frame forms the force transducer. The geometry of the force sensor frame was selected such that the displacement of the face of the sensor is minimal for the expected ratio of normal to downward friction force of about two. A detailed drawing of a force transducer is shown in Fig. 10.

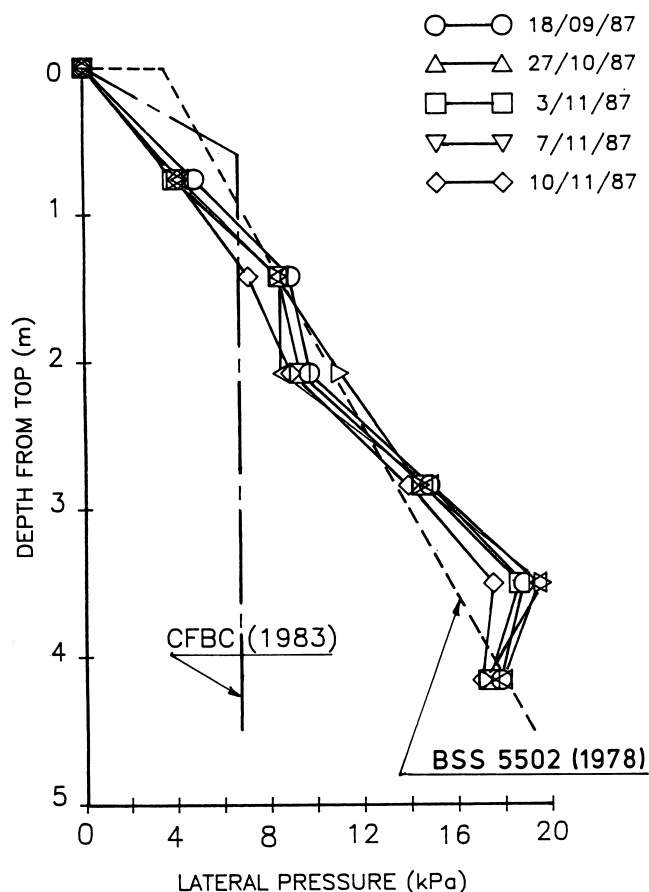
Figure 11. Average pressures at the six force transducer levels.

The lateral pressures measured at 11:00 h on each of five days are plotted versus the depth below the top of silage in Fig. 11. Each data point represents the mean of the three lateral pressures obtained from three transducers at the same level. Straight lines were drawn to connect corresponding means at the six levels thus providing five pressure profiles each based on 18 measurements. The design pressure curve of CFBC (1983) is also shown for comparison, as is the pressure diagram of

The results in Fig. 11 indicate that the static silage pressures normal to the wall of the bunker silo increased almost linearly with depth down to the 5th transducer, about 1.4 m above the silo floor. The rate of increase is about 5.1 kPa per metre depth. These findings are consistent with the soil mechanics theories discussed earlier. The observed pressures at the lowest row of transducers, about 0.7 m from the floor, were marginally less than those measured along the 5th row. This is probably due to the effect of friction with the floor of the silo. Similar reductions in pressure were observed near the floor of tower silos (Brunet and Jofriet 1985) and bulk vegetable bins (Anonymous 1987 a,b).

The results in Fig. 11 show that the pressures on most transducers exceeded CFBC (1983) provisions. The maximum value 3.5 m from the surface of the silage was three times that specified by the CFBC. The experimental results agreed fairly well with design pressures specified in BSS-5502 (1978). The major difference is the rate of increase in pressure which is  $3.5z$  in BSS-5502 and  $5.1z$  in the experiment. The difference may well
